**REVIEW**  
of  
**PUBLIC CONVENIENCES**  
in  
**West Lancashire Borough Council**

Rev 'A' - Initial issue 21/03/22

Rev 'B' - Update 01/09/22

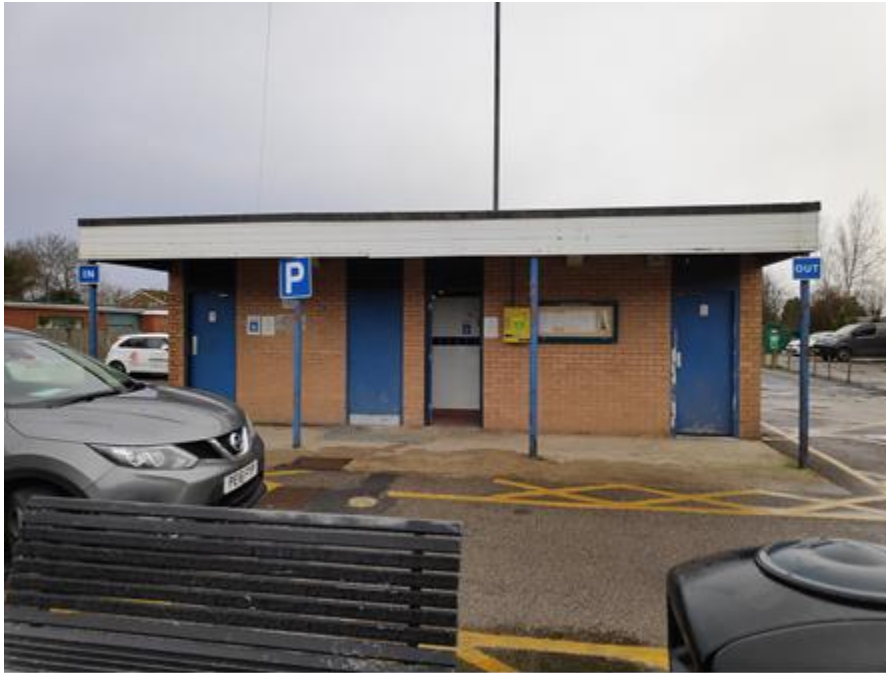
*Front Elevation*

Single storey unit of traditional cavity wall construction with a flat roof over.

This unit is in a reasonable condition and would benefit from a refurbishment.

In the last 18 months the toilets were damaged by youths which was dealt with by the police.

People are also sleeping and drinking in the toilets but generally any vandalism is not considered to be particularly serious.

- a) Rectify vehicle impact damage to rear and side wall (facing car park entrance). Install barriers to provide protection in the future
- b) Replace PVC fascia.
- c) Repaint steel posts(structural) to canopy.
- d) Repairs to concrete apron.
- e) Remove doors to Gents/Women/Wheelchair and replace with steel security type.
- f) Mechanical ventilation system - new fans and repairs to ducting.
- g) Internal work to toilet areas including pressure washing and replace damaged tiles.

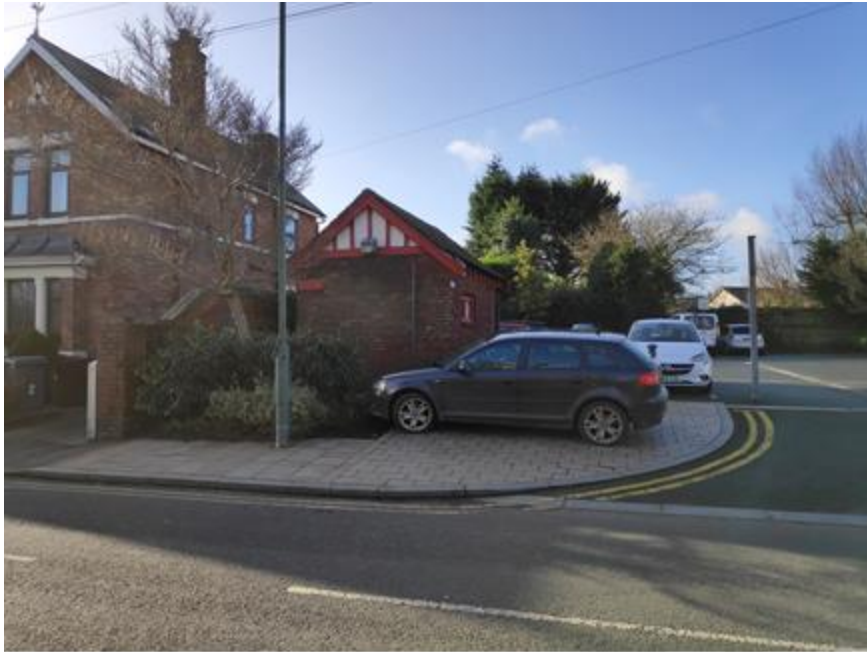
*Ladies Toilet*

Two separate units. When the car park is viewed from School Lane, the Gents & Wheelchair Toilet is located to the right of the entrance and the Ladies to the left.

Both units are of traditional construction with a tiled ridge roof.

From a building construction point of view the units are not in a good condition but to extend their life it is possible to undertake extensive repairs and refurbishment to include internal fit outs.

The Gents are in regular use but the Ladies is not and this may be due to its condition and to the location of the entrance being accessed via a narrow side passage which is not visible from the road.

The access to the Ladies toilet is via a narrow concealed passageway and is considered to be a safety risk to users. The Gents access is similar, but since it can be seen from the road the safety risk is not as high as the ladies. However, in view of the foregoing, the entrance to both toilets needs to be repositioned to the elevation facing School Lane.

- a) Take down areas of wall affected by lateral movement i.e. bowing (*ladies only*) and rebuild.
- b) Remove existing angle section lintels above the window and door openings and replace with galvanised lintels.

- c) Overhaul roof including renew/repair barge boards, fascia, gutters and rainwater pipes etc.
- d) Repointing required to areas of brickwork.
- e) Replace windows.

- f) Reposition entrance to front elevation and fit new steel door (*ladies only*).
- g) Reposition entrance to front elevation and refit existing new steel door (*gents only*).

- h) Infill existing door openings with cavity brickwork.
- i) Fit maglocks and security system to doors.
- j) Render external elevations to conceal work undertaken in a-h) above.

- k) Remove overgrown vegetation.
- l) Internal fit out to suit new access arrangement.
- m) External and internal redecoration/cleaning including new vanity units under wash handbasins.

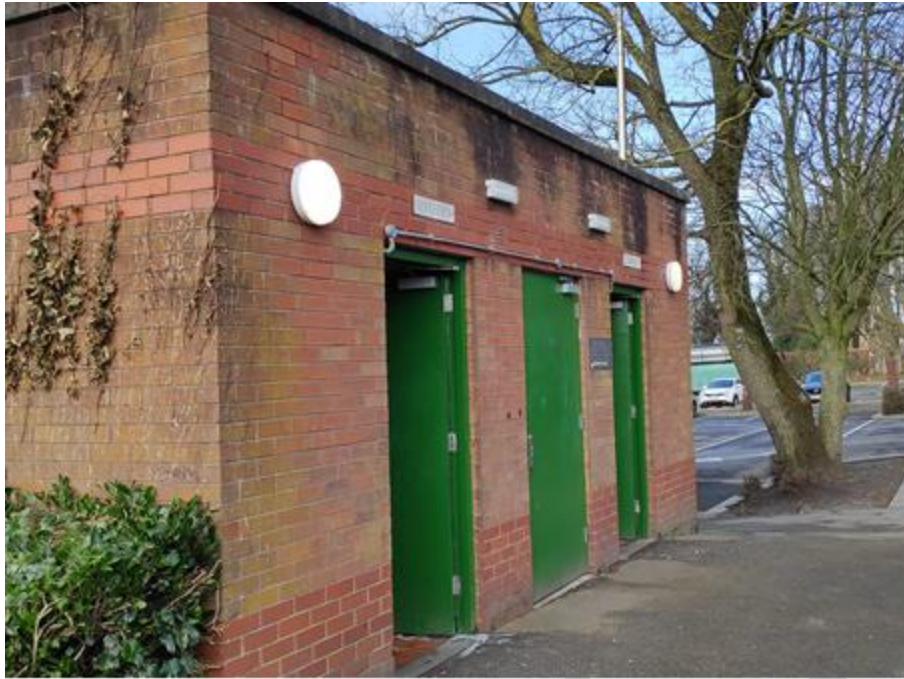
*Front Elevation*

Single storey unit with a parapet and flat roof. The unit is located within the park and is adjacent to the car park of Park Pool Leisure Centre.

This unit is in a reasonable condition and would benefit from a refurbishment.

Although there is some CCTV coverage, the toilets are frequently subjected to vandalism and this is a known ASB hot spot with both local youths and those travelling in from Maghull. A McDonalds is opposite which attracts youths to the area.

- a) Fit new steel doors and paint.
- b) Repoint joints to concrete parapet copings.
- c) Clean external signage.
- d) Replace ventilation louvres (6no.) and decorate.
- e) Fix steel plate to rear plant room door and decorate.
- f) Clean and polish all internal stainless steel fittings and wall linings throughout.
- g) Install maglocks to doors and walls. Connect to existing installation.
- h) Redecorate ceilings and timber coving throughout.
- i) Overhaul ventilation to wheelchair WC.
- j) Repair stainless steel linings.

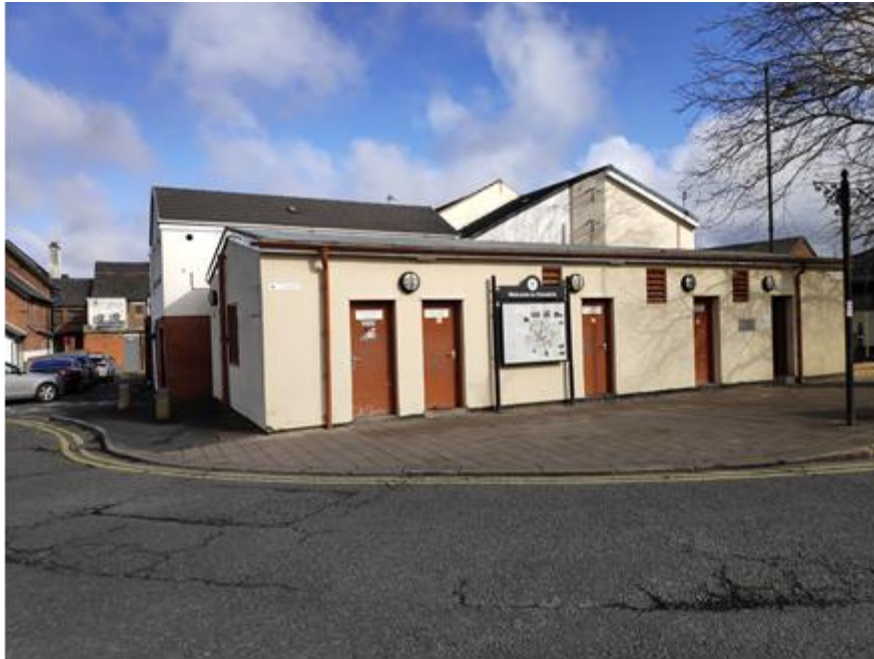
*Elevation facing Market Way*

Single storey unit with a dual pitch felted roof and external walls which are rendered (painted).

This is by far the largest unit in the borough and as well as the standard provision of public toilets it also houses the following:-

This unit can be classed as being in the best condition of all the units and would benefit from a refurbishment.

- a) Replace Market Traders' Washroom Door with steel security door and repaint other doors throughout.
- b) Repairs required to the external render at the position of the wall drip bead and decorate to match existing.
- c) Clean out rainwater gullies.
- d) Paint ceiling and pelmet.
- e) Clean internal walls patch repairs to tiles.
- f) Overhaul ventilation system.
- g) Repaint balustrade to wheelchair ramp.
- h) Repaint vertical timber wall cladding to elevation facing Moorgate.
- i) The passageway between this unit and 14 Moorgate is a trip hazard and a security issue. Clear out debris and re-lay paving to this area. Fix a security fence to both ends of the passageway and incorporate a locked gate to one end.
- j) 2 no. rainwater pipes missing to the rear elevation - fit new and connect to gutter.

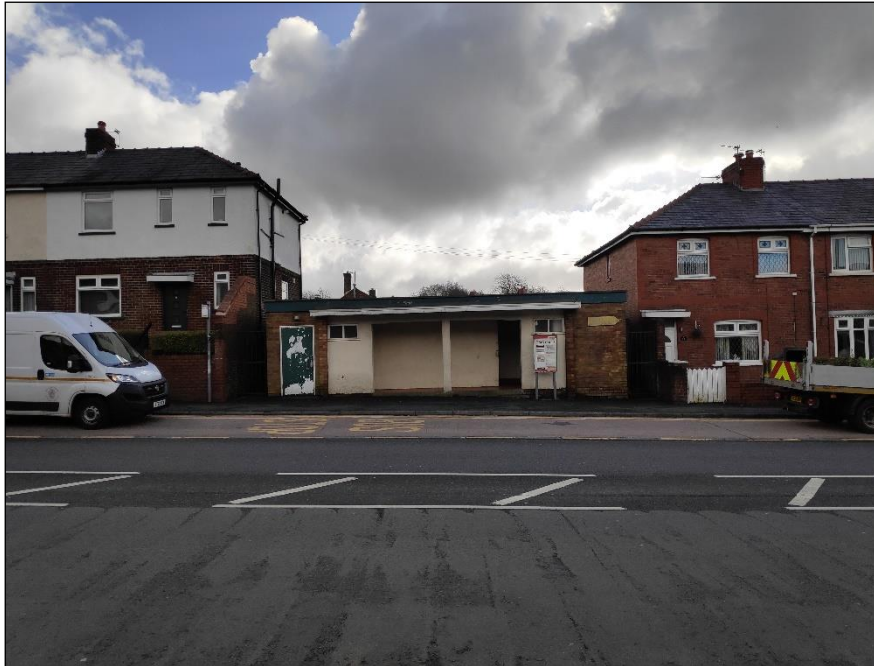
*Front Elevation*

Single storey unit of traditional construction with a flat roof over. Externally the walls are rendered (pebble dashed).

A bus shelter and canopy are located at the front and 4no. lock up garages are located to the rear.

This unit would benefit from being refurbished.

The unit is subject to vandalism eg damaging toilet seats, wash hand basins, doors etc.

- a) Repair and repaint fascia board.
- b) Clean down render and repaint.
- c) Remove 3no. doors and replace with steel security doors.
- d) Clean ceiling throughout to remove mould growth and paint with anti-condensation paint.
- e) Power wash all floors/wall tiling and replace damaged tiles.
- f) Remove vandalised wash hand basin and refix on solid wall.
- g) Renew flat roof.
